Sarjeant Art Gallery

Collection Storage Issues

Preliminary Evaluation & Interim Recommendations

Following a Site Visit on 17 October 2007

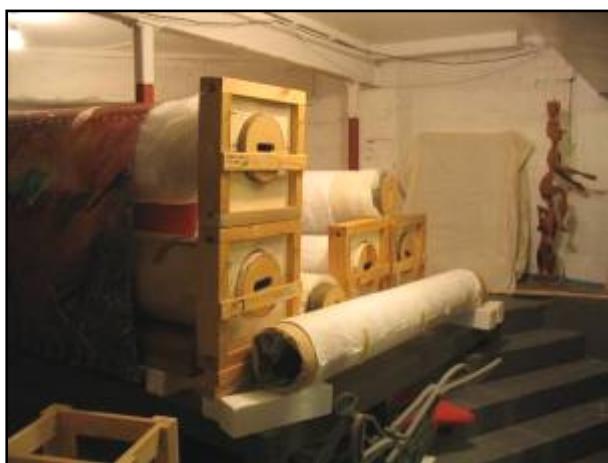
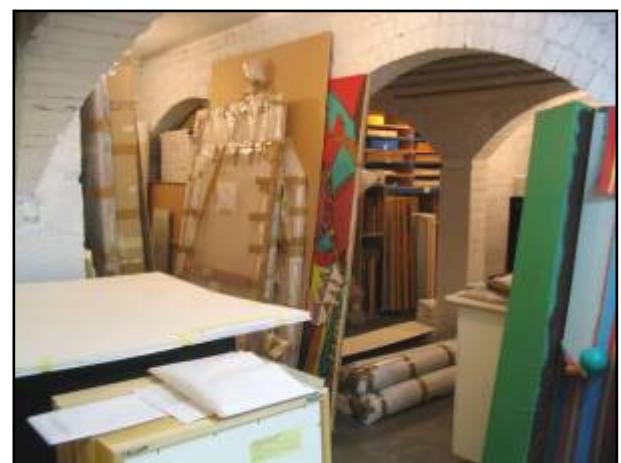
- The ceiling height is very low with structural arches further reducing the height in many areas
- Floor levels vary
- Masonry surfaces (walls and ceiling) are very rough with open pointing
- Retro fitted HVAC services for the galleries above intrude into the space
- No direct environmental control
- The collections are densely packed into the spaces fitted out with a variety of largely makeshift shelves and rack systems

Sarjeant Art Gallery: Collection storage in the basement

- Not all of the current collections can be accommodated in the basement of the Sarjeant Art Gallery, at a guess probably only 30% of the current volume if the purpose is to create storage conditions along contemporary practice and standards
- The entire basement would require evacuation for the duration of a project of renovation
- Existing HVAC ducting for the Galleries must either be removed or isolated from the storage spaces with a sealed wall

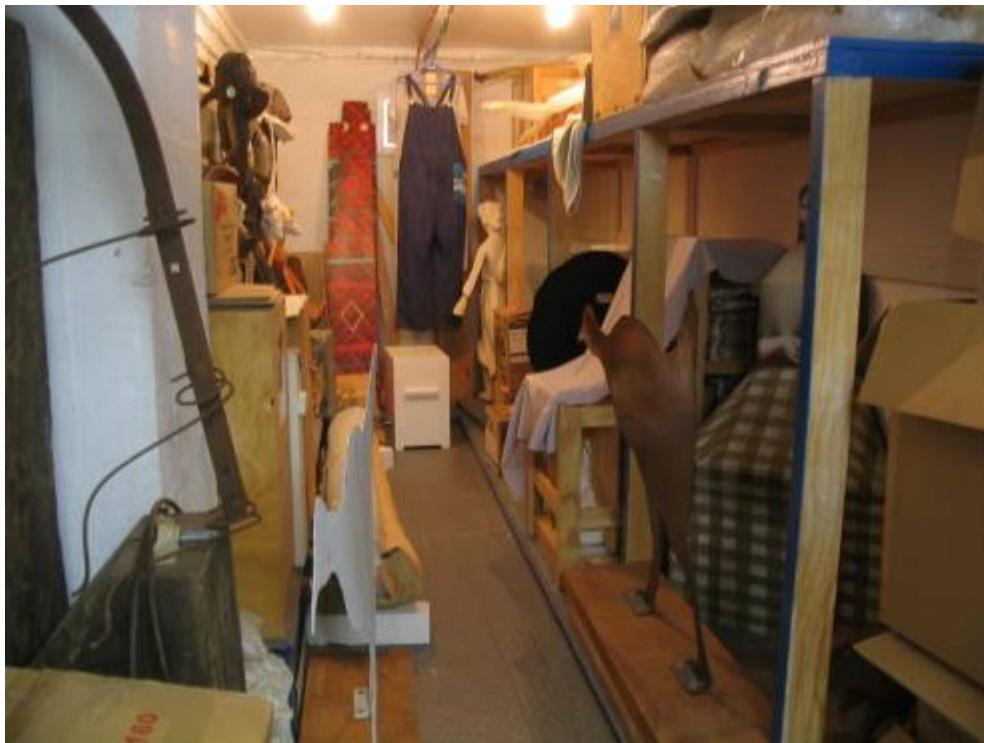
Safe access is not possible and risks damage to artworks. Cluttered corridors and impeded access are also hazardous to staff in particular during emergency evacuation procedures

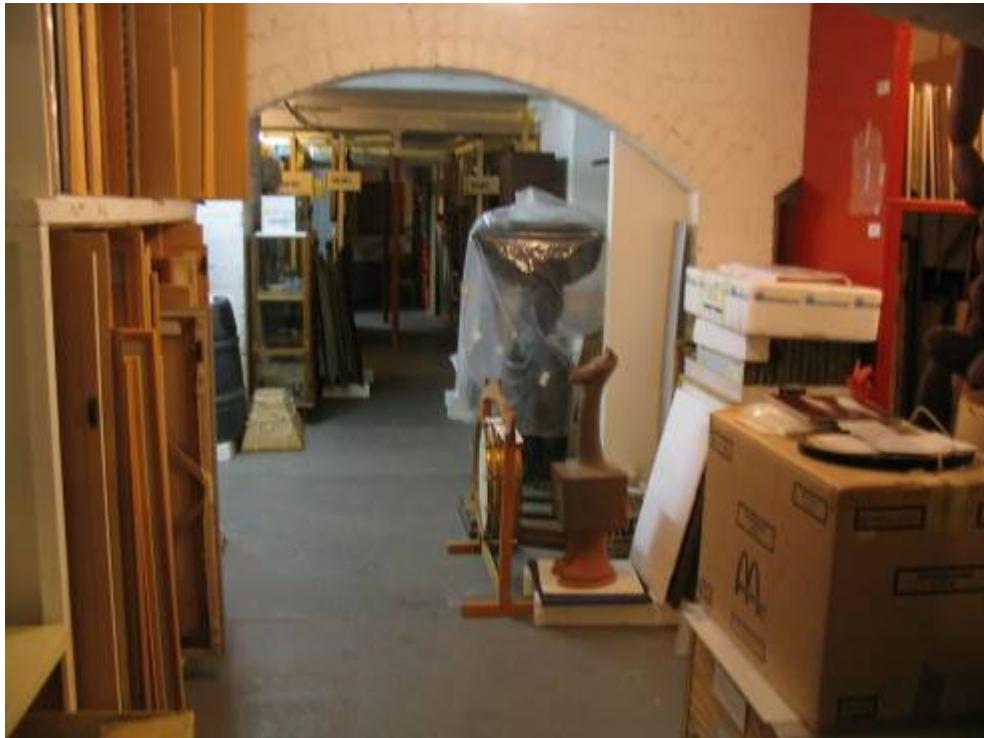
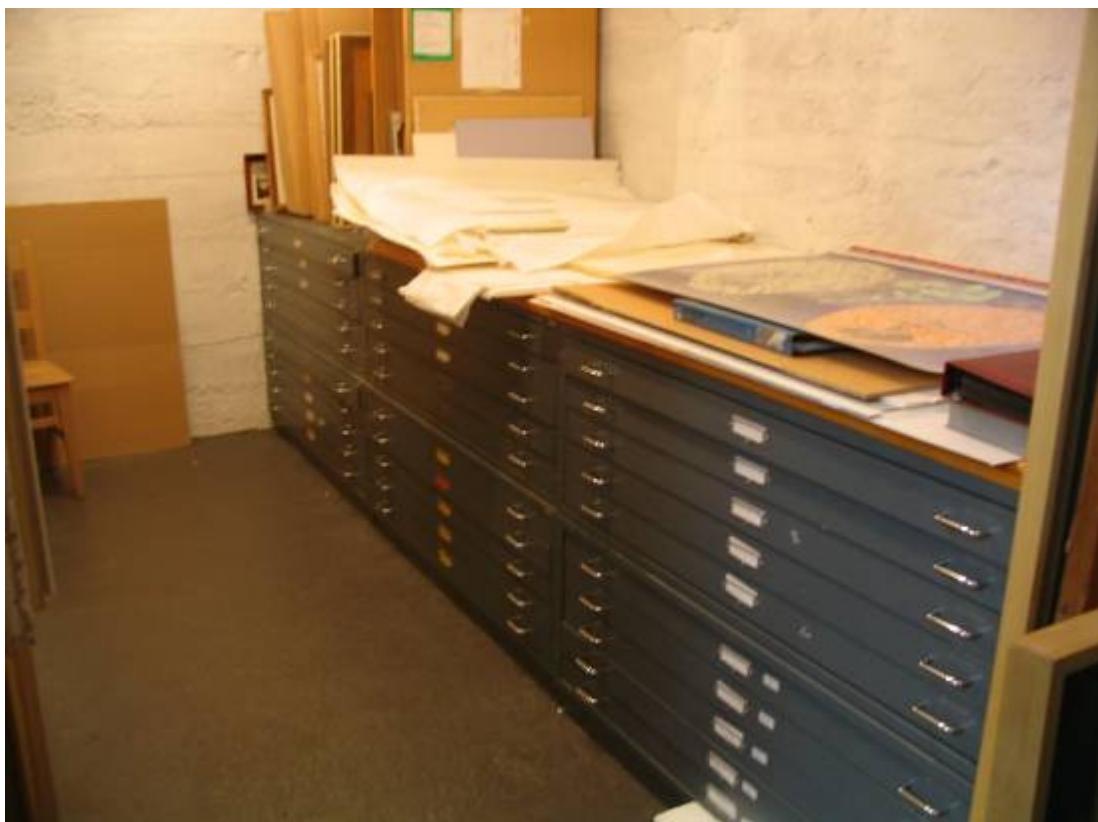
Makeshift work areas place artworks at risk and affect staff morale because it creates inefficiency

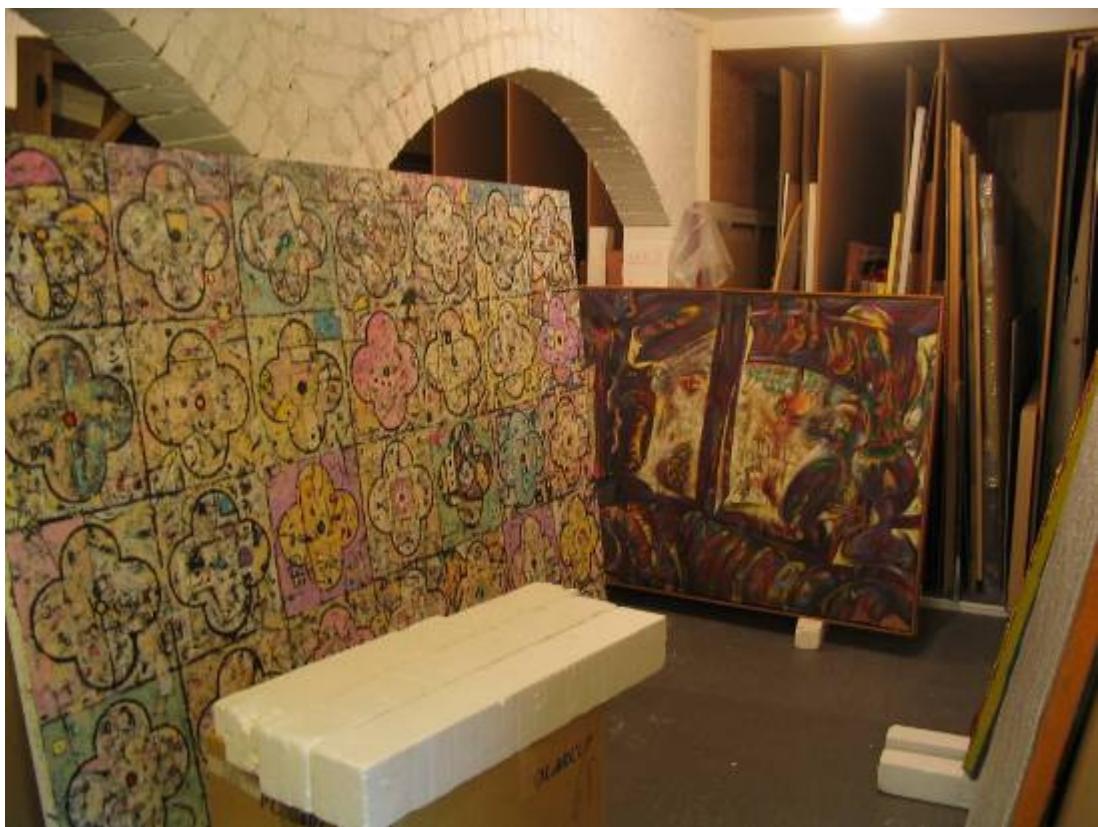
Safe storage of large works is not possible
